PCBs in Lighting Fixtures in Schools

Presentation by Judith Enck, EPA Regional
Administrator, US EPA Region 2
May 2012

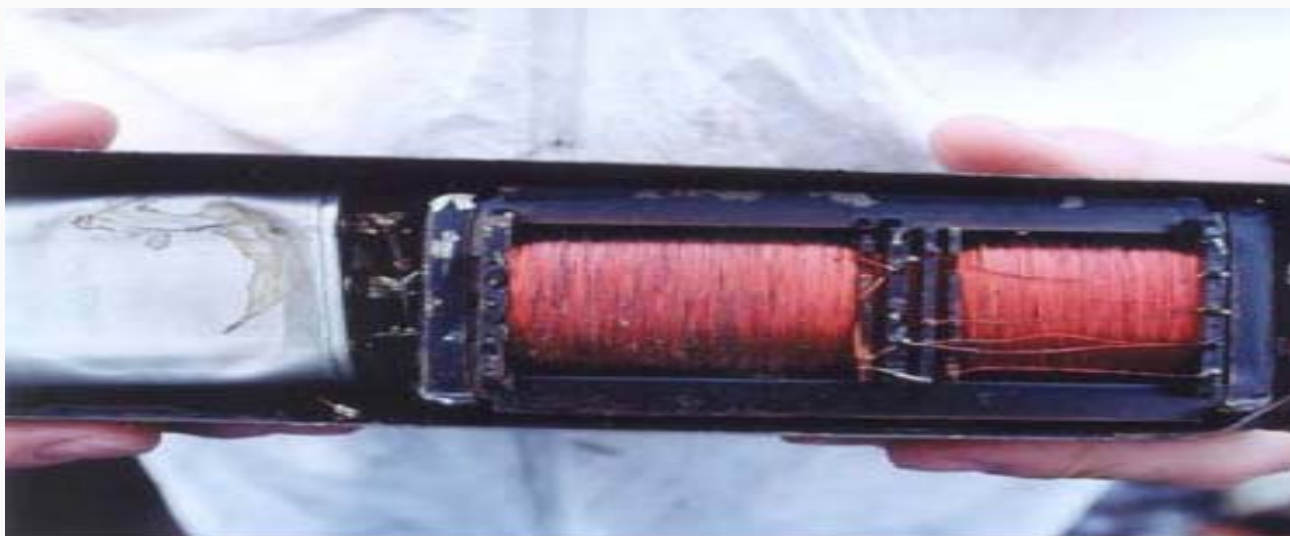
PCB-containing Ballast

- Older ballasts have a transformer to reduce voltage, a small capacitor that may contain PCBs, and some have a thermal cut-off switch and/or safety fuse.
- Potting material, a tar-like substance, is used to surround components to muffle the noise of the ballast. This material may also contain PCBs
- If PCBs are present in the capacitor, the amount ranges from approximately 1oz to 1.5 oz
- The ballasts for high intensity discharge (HID) lamps can contain between 3 oz and 14 oz PCBs

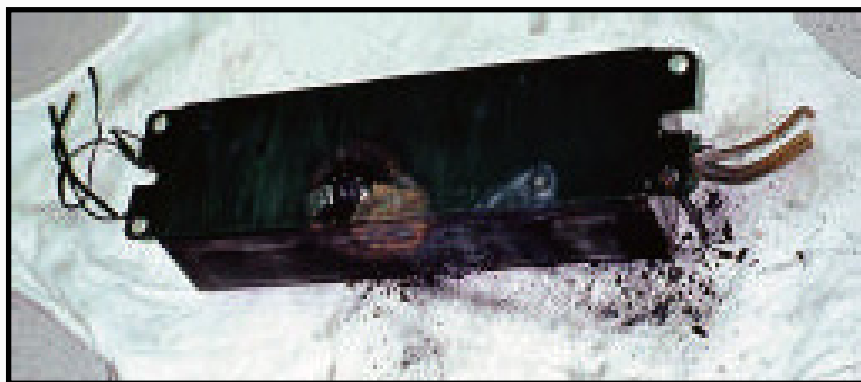
Types of Ballast Failures

This ballast sparked a fire at a southern California school in 1999

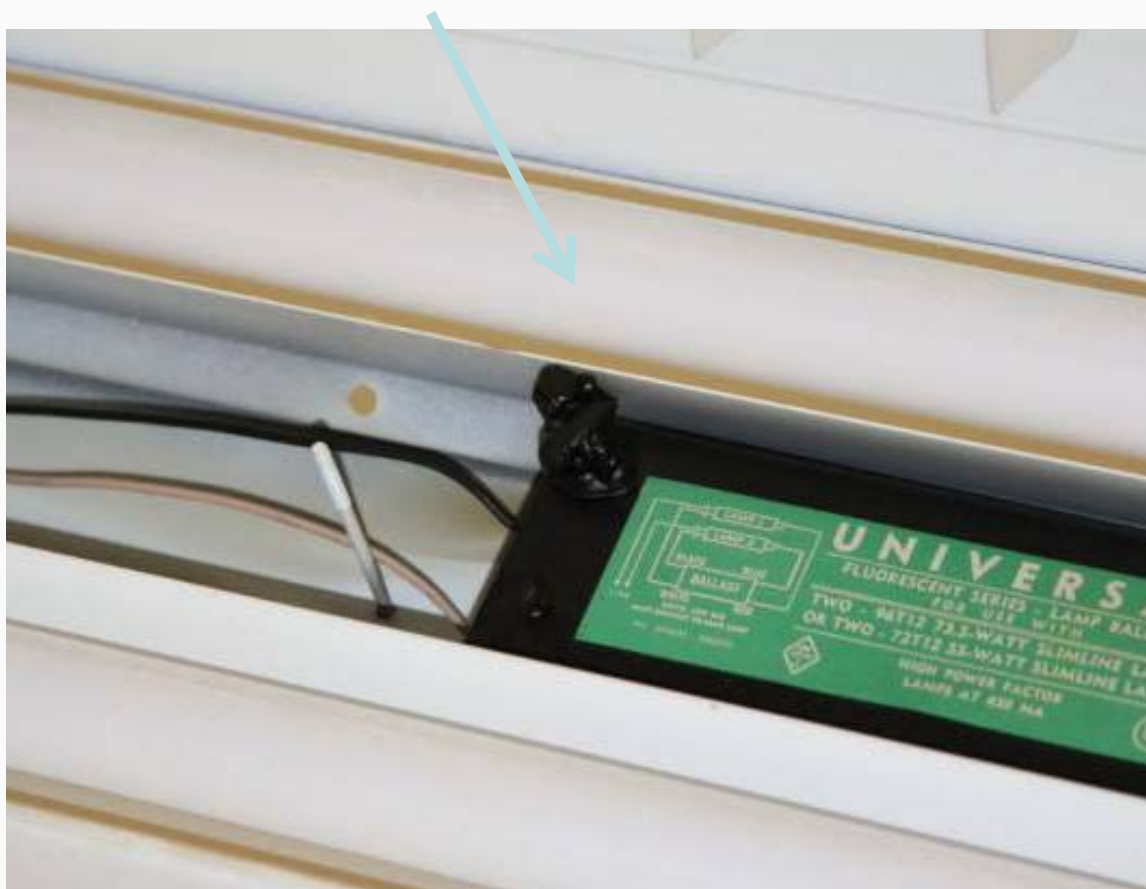
Material Leaking From Corner of Ballast

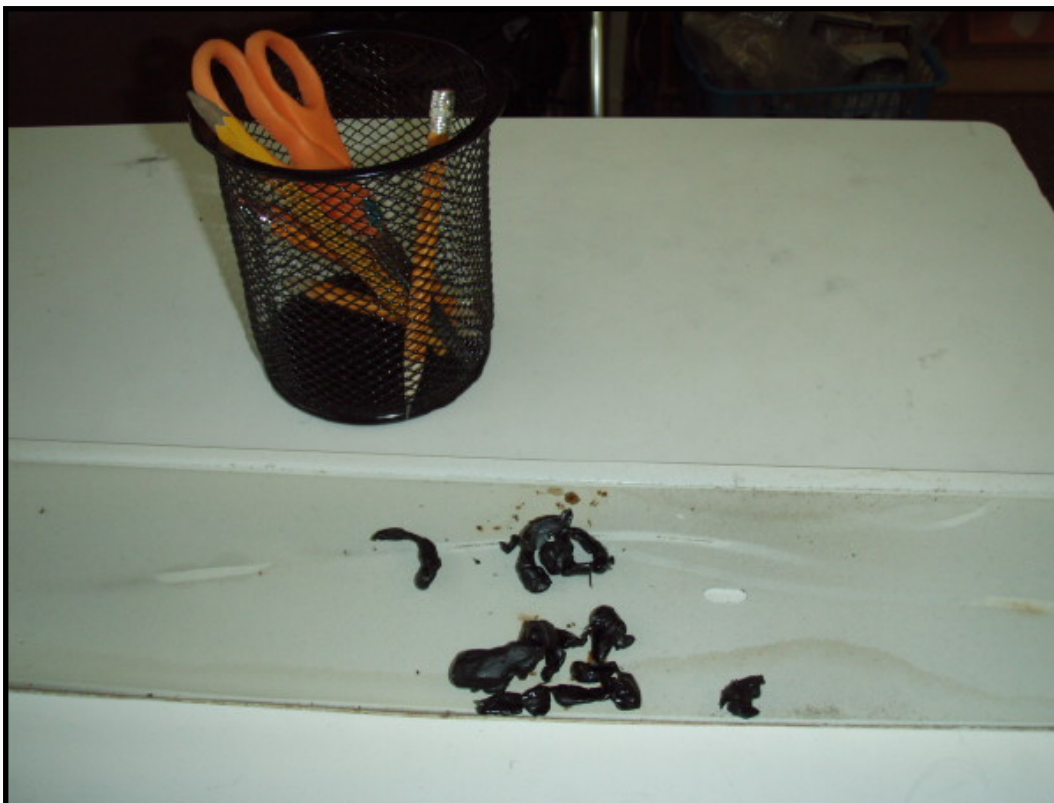
Tar-like Globules

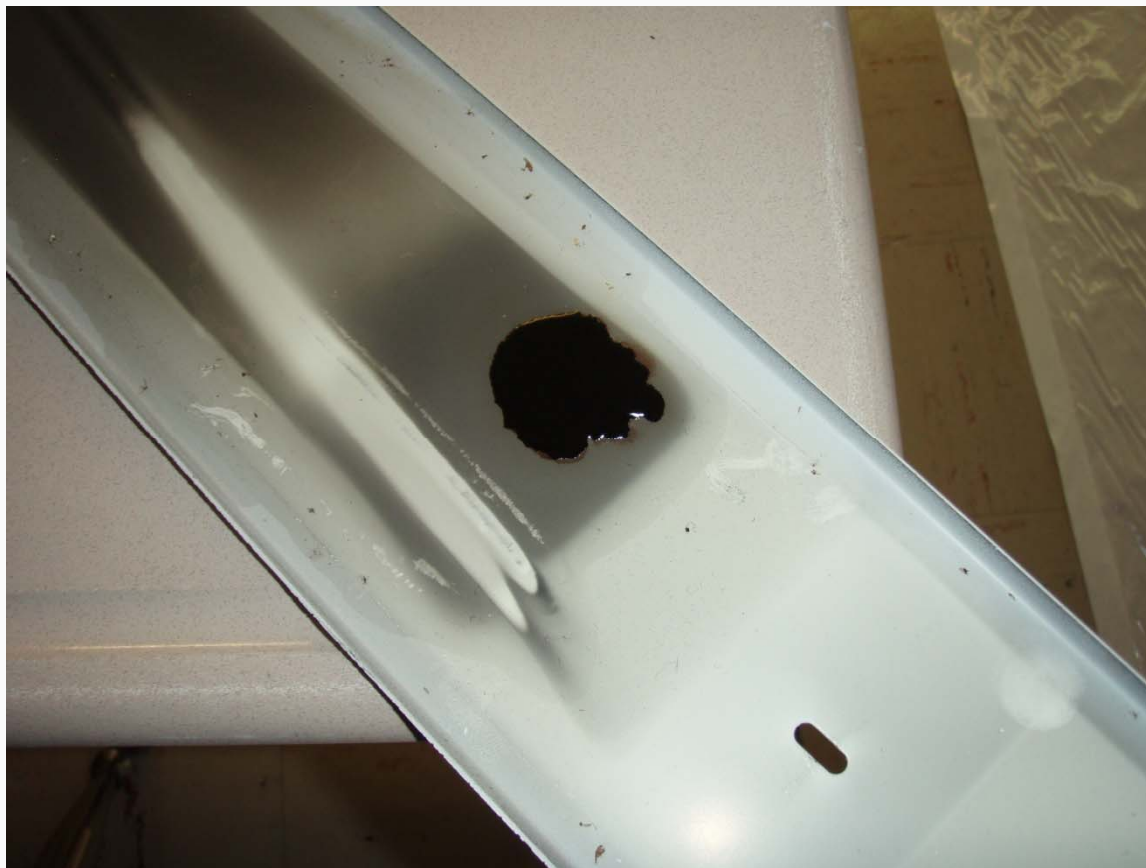
Leaked Potting Material

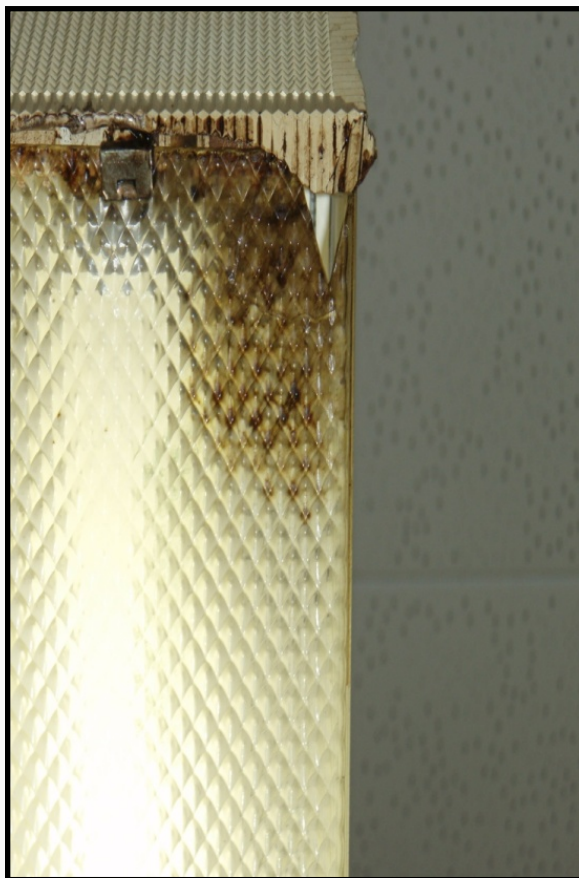
Oily Stains

- Burned –out lights that don't work after bulbs are changed
- Evidence of oil stains on light fixture housing, floor tiles or carpeting below light fixtures
- Previous incidents of smoke or burning odors requiring custodians to service lights
- Previous incidents where custodians removed or took apart a fixture to replace parts.

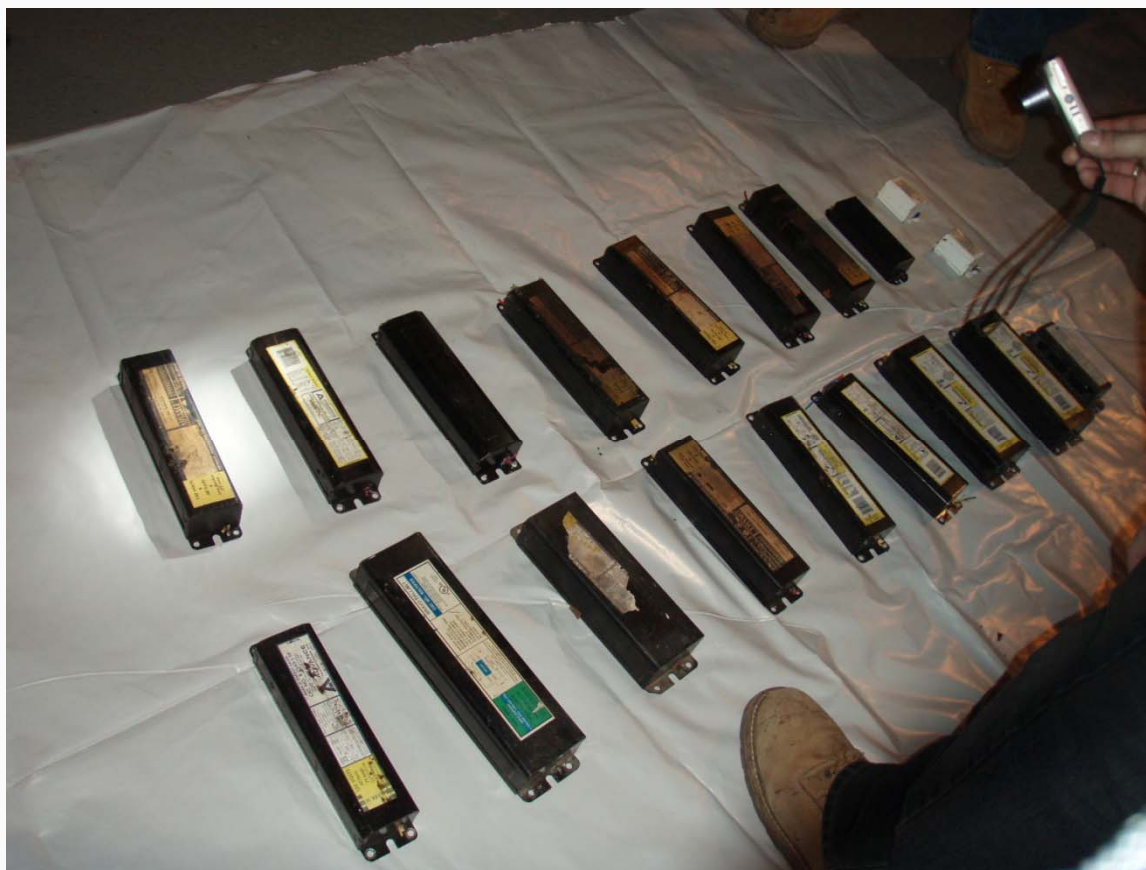
Ballasts Come in Various Sizes

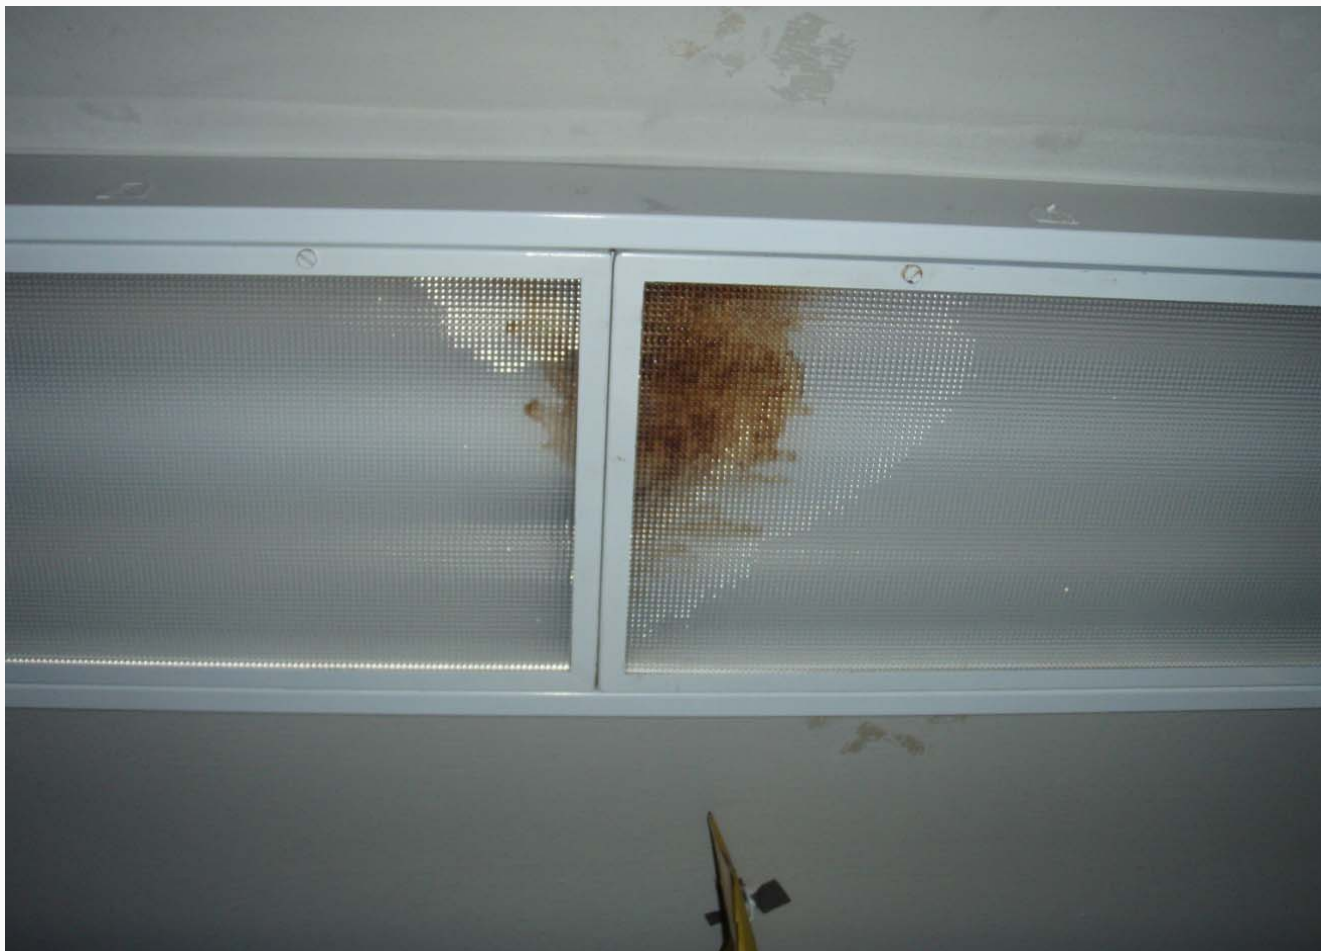
“Box” Type Fixture

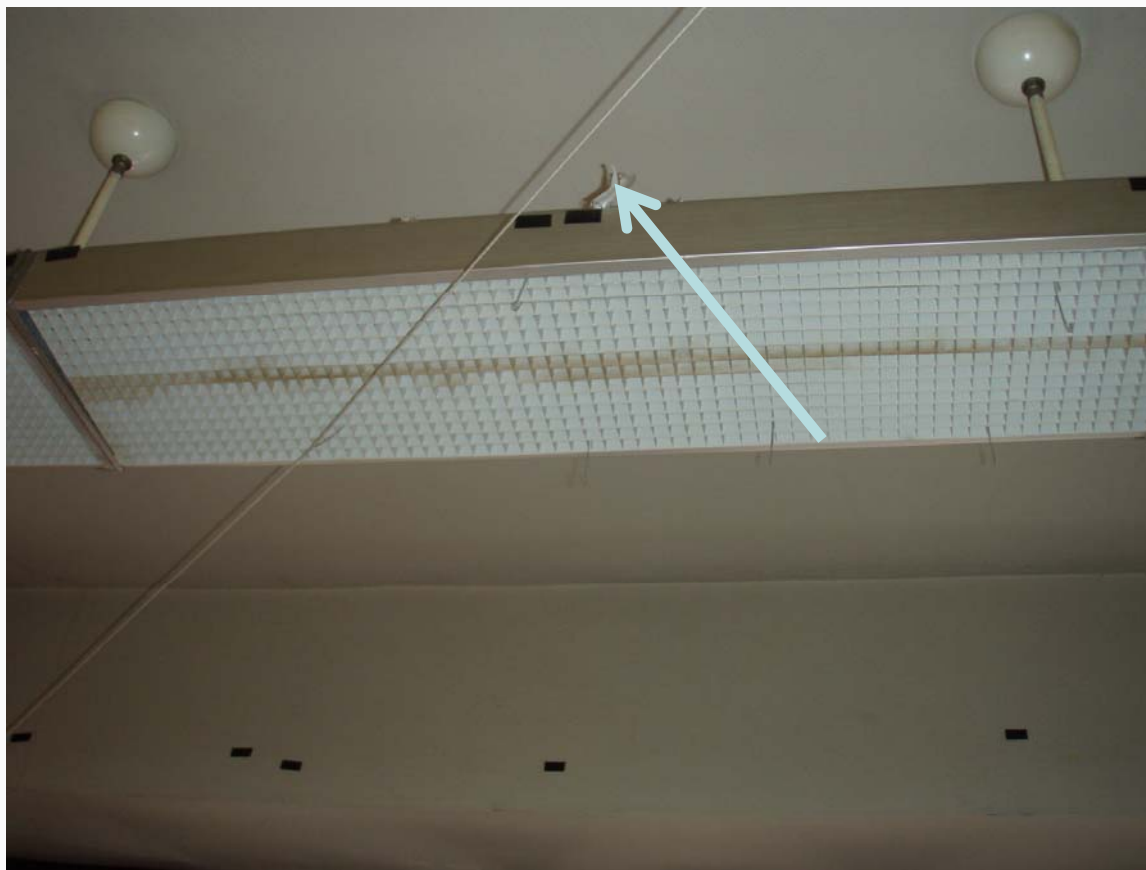
“Honeycomb” Type Fixture

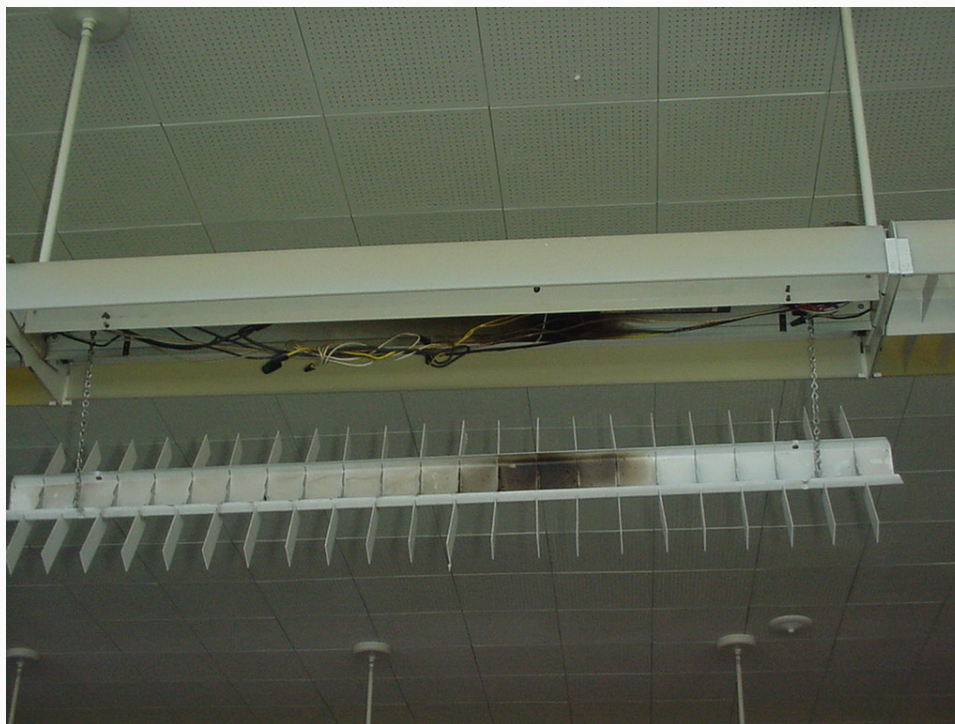
Ballast Location

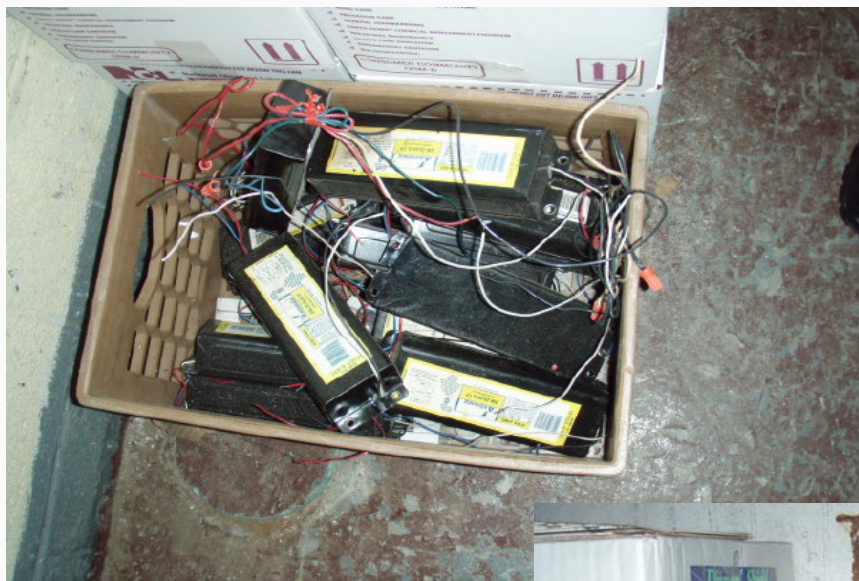
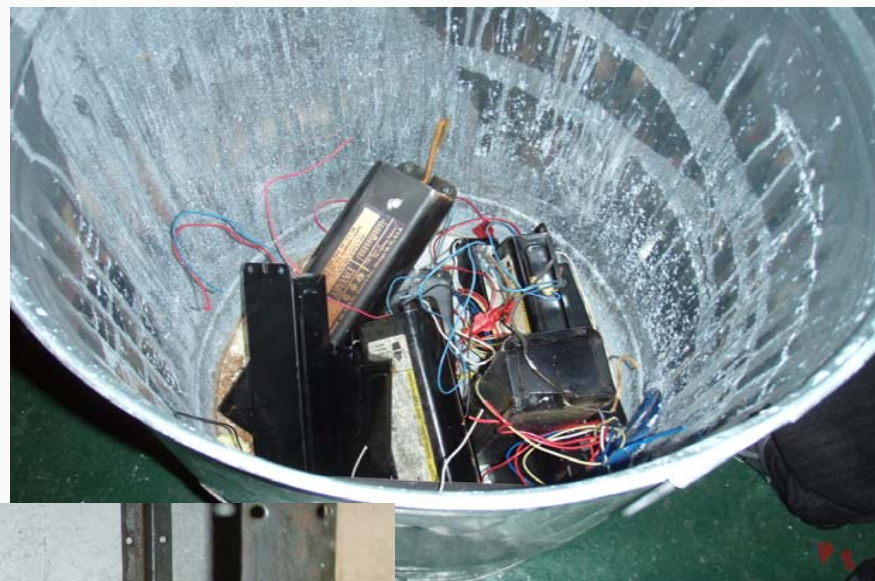
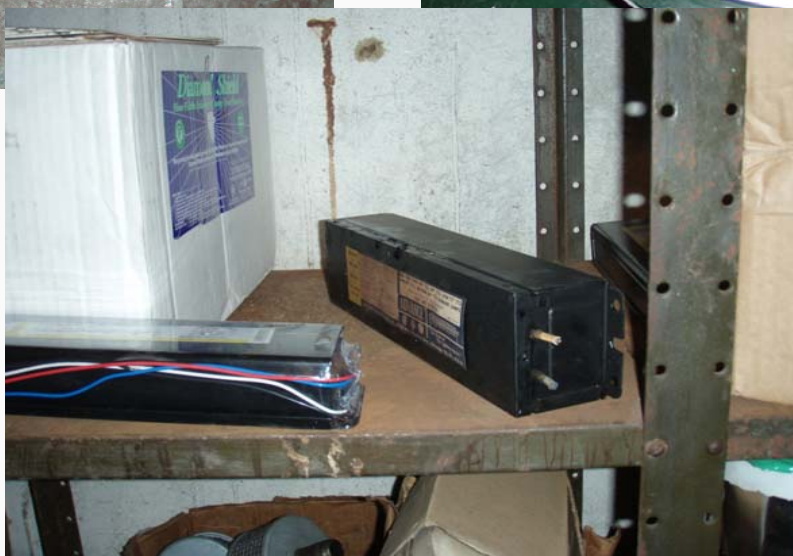
Improper Storage of Old Ballasts

- Disconnect and remove all ballasts and fixtures as appropriate as well as incidental PCB-contaminated items, fluorescent tubes from the light fixture housing and compartments;
- Provide the appropriate containers and packing materials for packaging and storing the four possible types of waste streams:
 - Intact, non-leaking, PCB-containing ballasts;
 - Leaking PCB-containing ballasts and cleanup wastes generated by handling and decontaminating areas where leaking ballasts were discovered;
 - Ballasts that contain no PCBs; and
 - Fluorescent light bulbs.

- Maintain a record for each space where lighting fixtures are removed including how many leaking vs. non-leaking PCB-containing ballasts were removed from each space
- Package and label drums according to federal, state, and local regulations.
- Store the drums until a transporter currently licensed for transportation of PCB waste removes them to the appropriate disposal facility.
- Ballasts that are totally enclosed and not leaking can currently be disposed of in a solid waste landfill. However, most landfills will not accept such waste so most will be disposed of in a TSCA approved landfill or destroyed using chemical or thermal destruction methods.

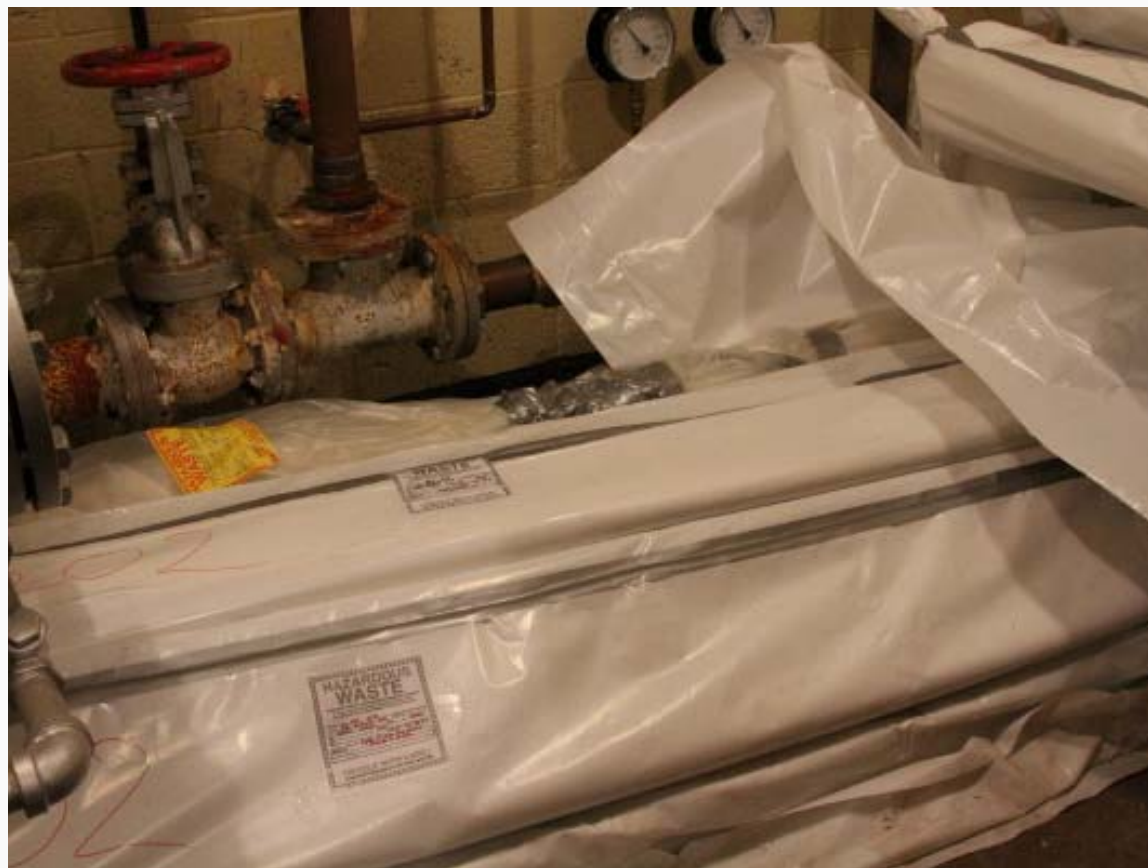
Removed Fixtures not Labeled or Stored Properly

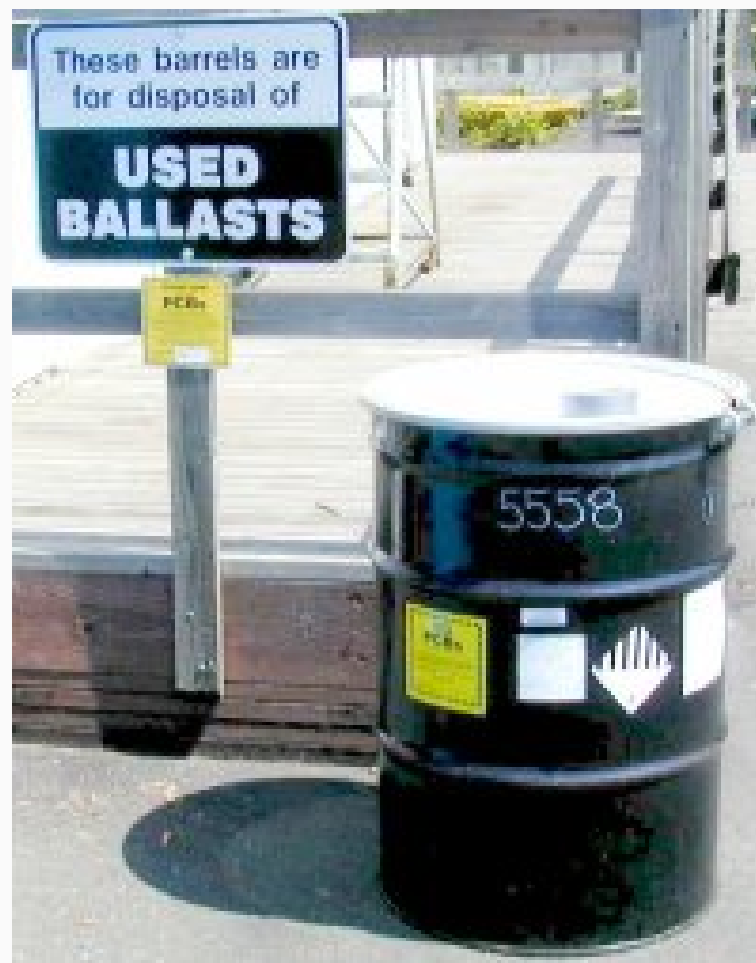
Proper Methods for Storing Ballasts
